Repair, Strengthening and Upgrading of Steel Bridges in The Netherlands

Abstract

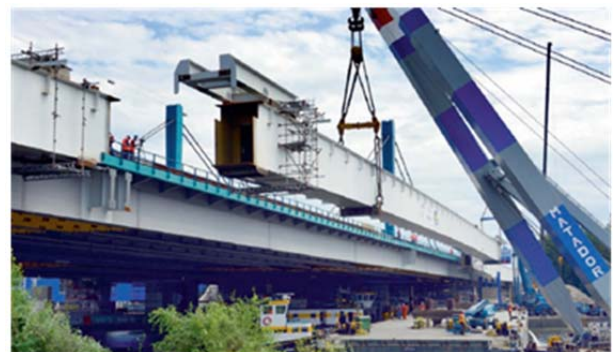
Figure 10. Installation of strengthening girder, Galecopper Bridge

At the Galecopper Bridge, the bridge load was not distributed evenly across all main beams due to torsional weakness of the bridges. As a result, the bridge is strengthened by means of four steel box girders either side of the bridges, Figure 10.

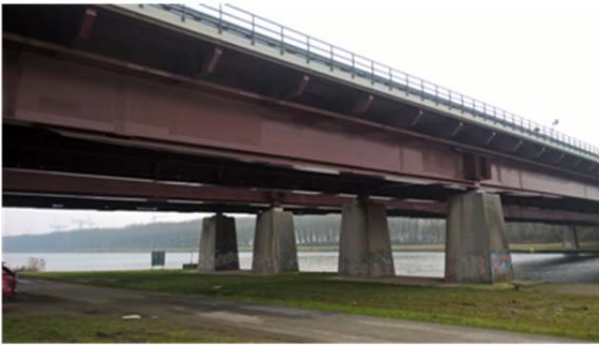
Figure 11. Strengthening of the main girder, Kreekrak Bridge

The recalculating of the Kreekrak Bridge showed that the main girder did not fulfill the strength and fatigue requirements. Therefore, reinforcing measures were taken, consisting of a T-shaped profile with a thick bottom flange in the areas where the stresses are too high (Figure 11), at the same time strengthening the connections in the main girder.

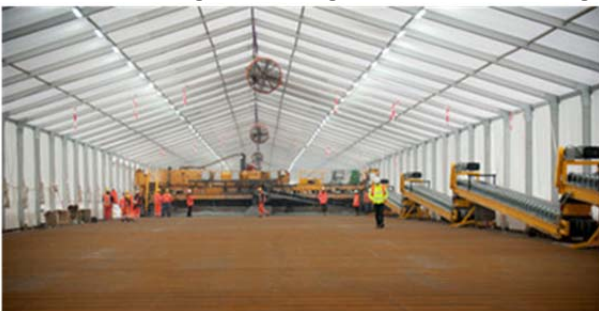
Figure 12. Strengthening by HSC, Kreekrak Bridge

Fatigue cracks found during inspection in several important steel highway bridges in The Netherlands, are the main reason to reassess these bridges. The fatigue problems occurred in the orthotropic steel bridge decks. As an extreme example, cracks were observed in the orthotropic deck plate of the Van Brienoord bascule bridge in Rotterdam in 1997, when the bridge was only 7 years old [4, 5]. These fatigue cracks were caused by the wheels of heavy vehicles. The designs of those days had rather thin deck plates making the orthotropic deck very susceptible to fatigue [6]. More cracks are expected to occur in the near future [4, 5]. One of the most promising ways to cope with fatigue in existing orthotropic decks is to add a layer of high strength concrete (HSC) on top of the deck plate, reducing the stress level in the orthotropic deck [7], as done at the Kreekrak Bridge, Figure 12. Also, at the Kreekrak Bridge, the web was strengthened against local buckling,

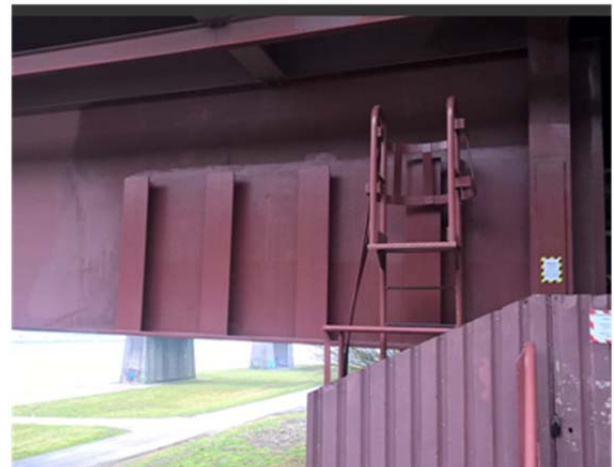
Figure 13. Strengthening of the web preventing local buckling, Kreekrak Bridge

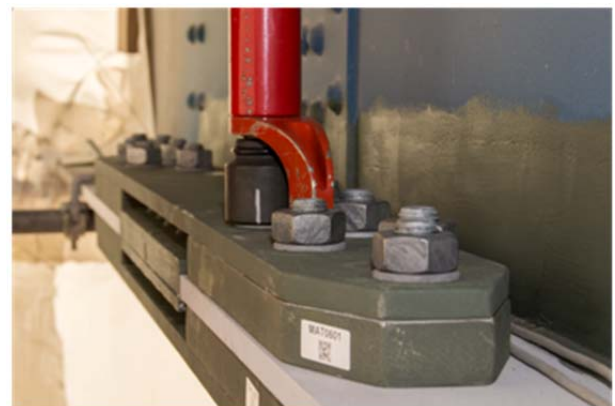
Figure 14. Original riveted connection bridged by a new preloaded bolt connection, Merwede Bridge

When recalculating the Medewede Bridge, the riveted connections in the main girders were shown to be possibly critical for fatigue. After inspection, these connections turned out to have fatigue cracks. As an urgent strengthening measure, these connections were bridged by new additional connections with preloaded bolts, Figure 14.

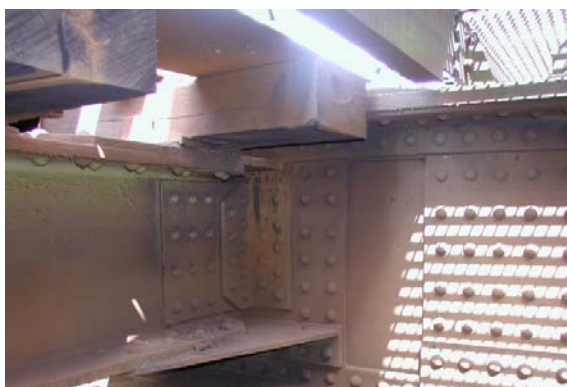
Figure 15. Traditional deck system

the world and it is necessary to have a reliable railway system. In order to prevent disruptions, the track must be in perfect shape. Preventing rail track maintenance is of extreme importance. Preventing corrosion protection maintenance is another important aspect. Preventing maintenance strongly influences the competitiveness of steel railway bridges [8]. The railway bridges built just after World War II have in most cases a traditional deck design consisting of cross girders and two longitudinal steel girders with bridge sleepers on top of them (Figure 15). This solution needs a lot of track maintenance and produces a lot of noise. Also, fatigue problems at the connection between longitudinal and cross girder may occur.

If a reassessment shows that the rivets in the connections between cross and longitudinal girders may form a fatigue problem (Figure 15), they are removed and replaced by preloaded injection bolts. This is only done in case fatigue cracks have not yet been observed. The hole is then drilled up, removing any possible invisible fatigue damage at the bolt holes, and the bolt is placed, preloaded and injected.

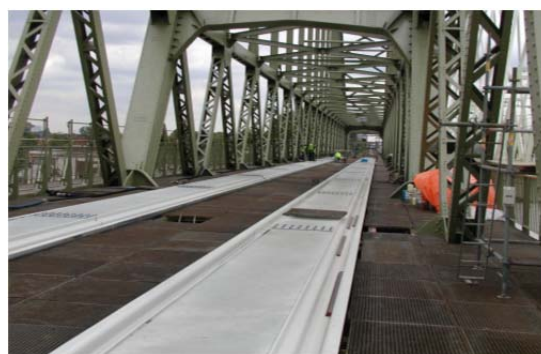
Figure 16. New silent bridge® decks

For fatigue, it is a good solution to replace the bridge sleepers by especially designed silent bridge® decks. This is a design with an acoustically optimal plate thickness configuration and rails embedded in a trough using corkelast. The stresses in the longitudinal girders are reduced and therefore the lifetime increased. To connect the silent bridge® decks to the longitudinal girders, the complete connection of the bridge sleepers is removed. By reusing the existing holes in the longitudinal girders, the silent bridge® decks can be connected using preloaded bolts. The upper flange plates of the new decks are continuous over the cross girders and therefore

strengthen the longitudinal girders at their connections with the cross girders (Figure 16). This gives lower stress levels at the connections and also the dynamic factor for the embedded rail of the silent bridge® decks is lower. Thus, the fatigue problems at the connection between longitudinal and cross girder can be avoided.
