# BISTABLE MECHANISM IMPROVES SETTING OF SWITCH RAILS

Jelte Bos MSc.  
Movares Nederland BV  
P.O. 2855, 3500GW Utrecht  
[jelte.bos@movares.nl](mailto:jelte.bos@movares.nl)

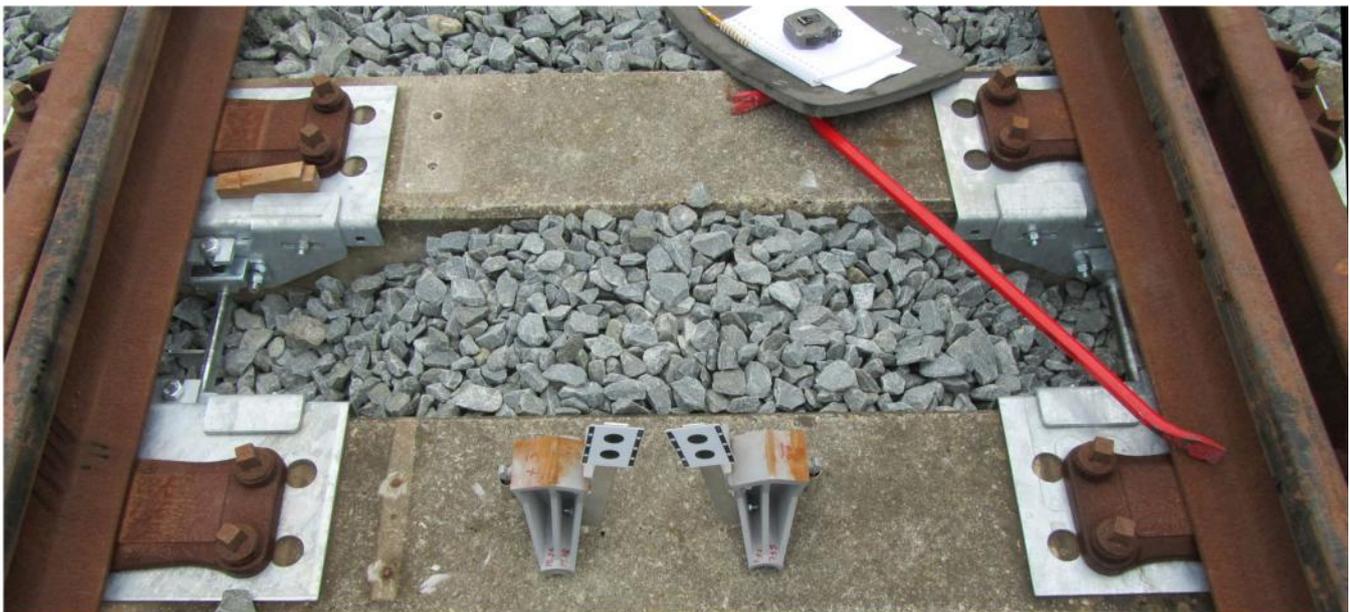
Figure 6 Disassembled blocks during inspection and measuring

The test showed constant behavior and after the test no wear could be measured. This means that even the 3D printed blocks meet the material quality required. It can be expected that the final production technique of injection molding will at least yield the same quality.
